**THE BLOCKLEY RETREAT FARM:
AN ANALYSIS OF AND
RECOMMENDATIONS FOR ITS REVITALIZATION**

A THESIS

Historic Preservation

1998

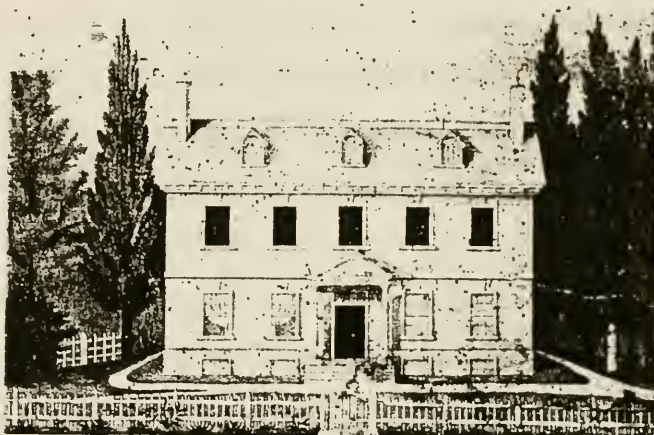
Figure 3 Blockley Retreat Farm in 1820, North Façade
Photograph of Unidentified Watercolor, Bc61, Z99 a & b, c.1820
Historical Society of Pennsylvania, Philadelphia, PA

For the purposes of describing the mansion house as it was built by Matthew McConnell, two highly detailed fire insurance surveys and a c.1820 watercolor are used (See Appendix B for Fire Insurance Surveys). Paul Busti requested the first fire insurance survey, dated March 15, 1806, after he had become the highest bidder at a public auction held for the Insurance Company of the State of Pennsylvania on March 8, 1806 (deed of purchase dated June 26, 1806). The Pennsylvania Hospital requested the second fire insurance survey, dated December 20, 1835, before they purchased the property in 1836. These fire insurance surveys give thorough accounts of the exterior and interior architectural features of the mansion house, while the c.1820 watercolor portrays an artist's account of the north and south exterior facades.

According to the 1806 fire insurance survey, the mansion house measured fifty-three feet wide by thirty-six feet deep.⁹ The two and a half story brick structure was capped with a gambrel, or "broken pitch" roof, which had cedar shingles painted red and copper gutters and down spouts. Piercing the roof were four symmetrically placed chimneys and six pedimented fanlit dormer windows with wood sash with six over six, nine by eleven inch lights. Along the eaves and across the gambrel walls ran a denticulated cornice. At the base of the house, the projecting brick foundation wall articulated the raised basement and its windows "with sash in them all around."¹⁰

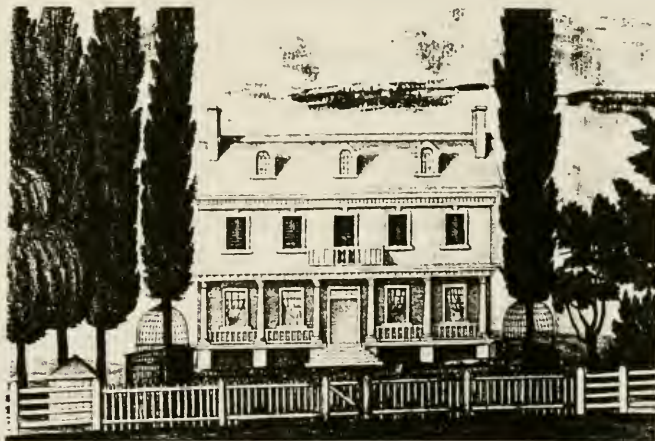
Figure 4 Blockley Retreat Farm in 1820, South Façade
Photograph of Unidentified Watercolor, Bc61, Z99 a & b, c.1820
Historical Society of Pennsylvania, Philadelphia, PA

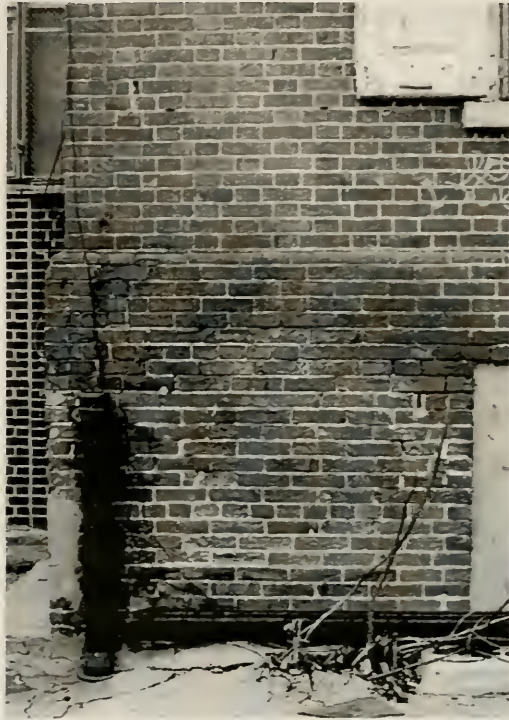
Figure 23 Missing Downspout. Ground Conditions and Masonry Saturation, 1998
Photograph by Author

¹²⁵ Harris, Session 6: Building Material Intervention, February 20, 1998. Sacrificial corrosion of aluminum down spouts to more noble copper gutters is a typical problem in historic properties. Copper downspouts are often stolen for their high value. As a result, owners replace them with less expensive and less noble aluminum down spouts. The cycle of corrosion versus the high expense of copper down spout replacement is a difficult problem.

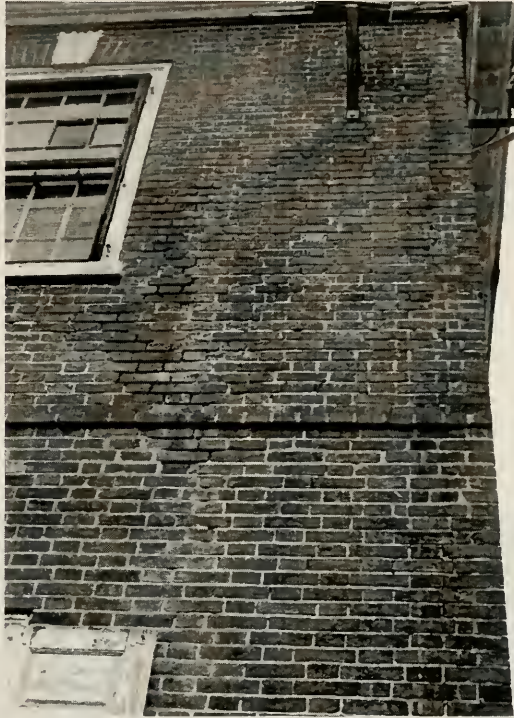
Figure 24 Brick Saturation Through Capillary Rise,
Efflorescence and Mortar Erosion, 1998
Photograph by Author

Mechanically, the new cementitious pointing mortar is harder than the original eighteenth century handmade bricks. The bricks expand and contract through hygroscopic and thermal expansion and the new pointing mortar, which should be the sacrificial material, causes the outer surface of the brick to spall. Once this protective layer has been detached, the interior and more susceptible portion is exposed to the elements and a cycle of brick saturation and spalling is developed.¹²⁸

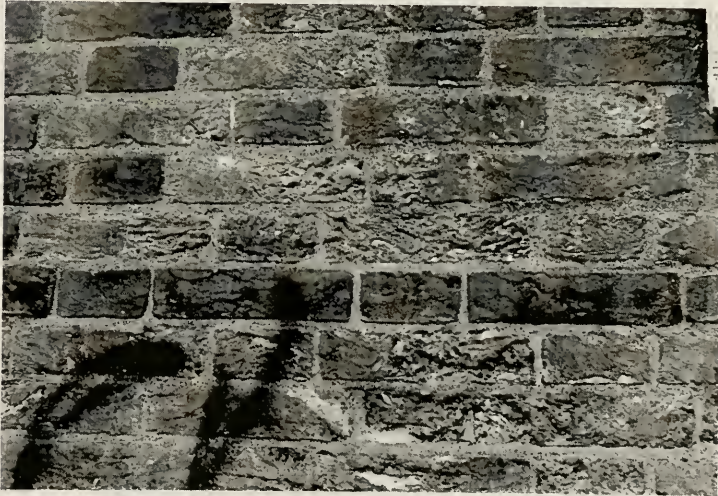
Figure 25 Spalling Caused by Brick Saturation Through Capillary Rise. 1998
Photograph by Author

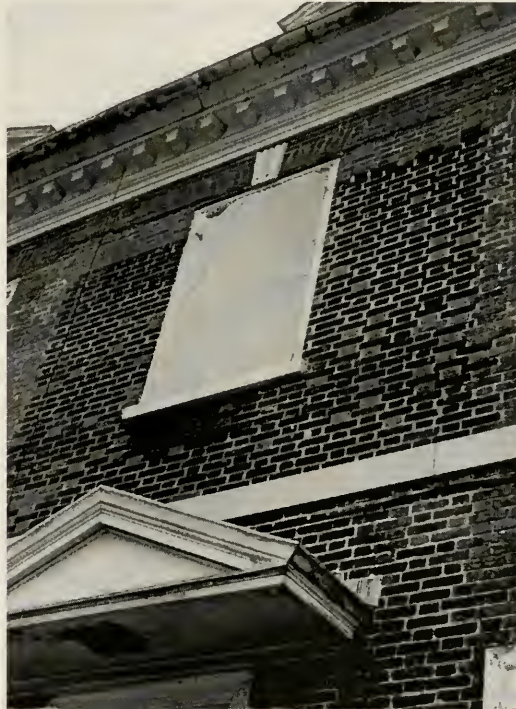
Figure 26 Inappropriate Masonry Infill, 1998
Photograph by Author

Aesthetically, the numerous pointing campaigns have resulted in irregular patterns along the building elevations. Adding to this awkward appearance, are areas where new bricks differing in color from those of the original have been used to fill in window openings and other masonry openings left from exterior alterations. The assumption is that the mechanical properties of the new brick differ from those of the original; however, there is no visible deterioration mechanism caused by these differing mechanical properties. Therefore, this inappropriate alteration is merely an issue of aesthetics.

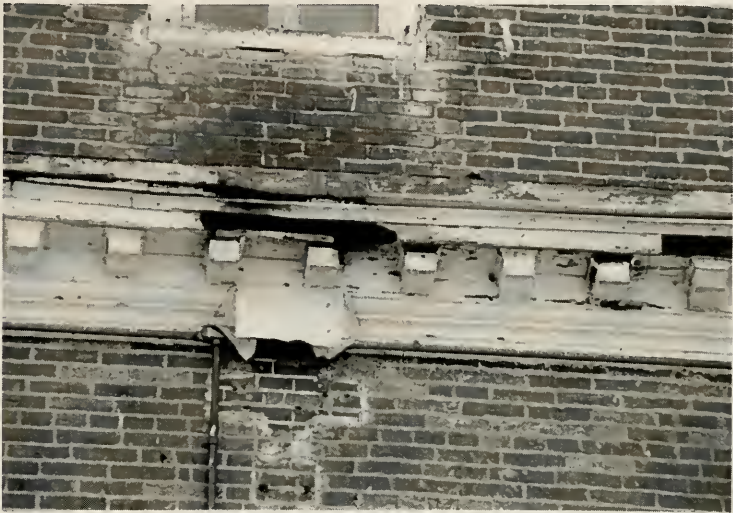
Figure 27 Wood Cornice Deterioration, 1998
Photograph by Author

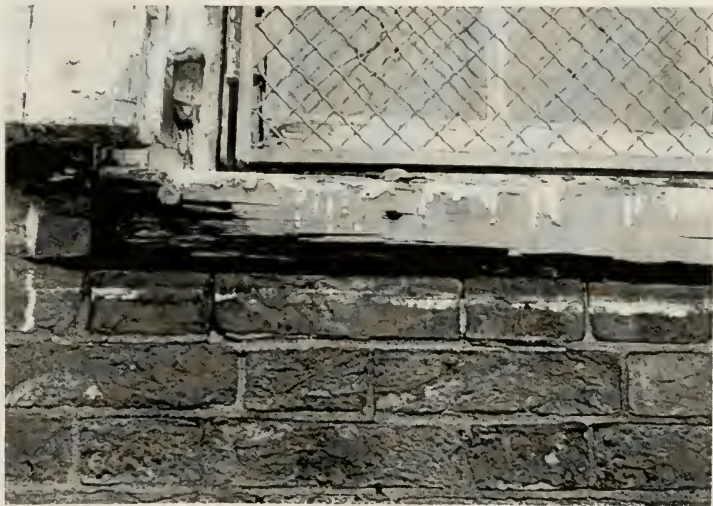
Figure 28 Wood Window Sill Deterioration, 1998
Photograph by Author

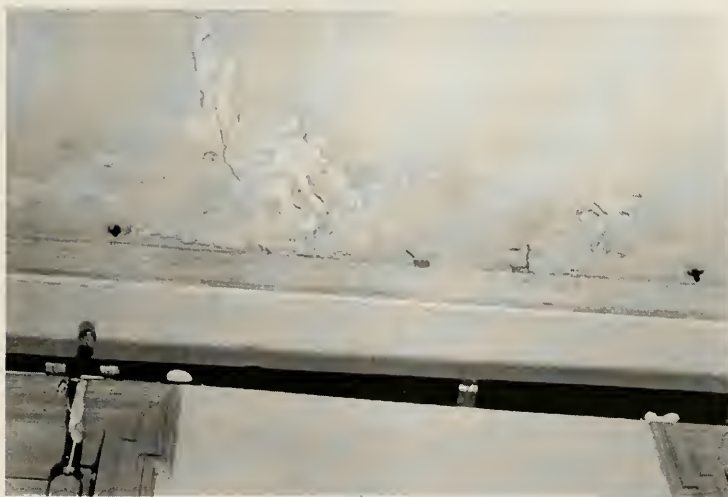
Figure 30 Deterioration of Ceiling Plaster Due to
Inappropriate Mechanical System, 1998
Photograph by Author

The second issue concerning interior finishes is not a result of natural deterioration mechanisms. It is the alteration, destruction and removal of interior fabric by man. This includes vandalism, the removal of decorative wood moldings, the addition of new floor coverings over original heart pine floors, the addition of new walls and doors, and the filling in of original interior and exterior openings. These obtrusive alterations have sacrificed the character of the house and are not consistent with an awareness of the architectural and historical significance of the property .

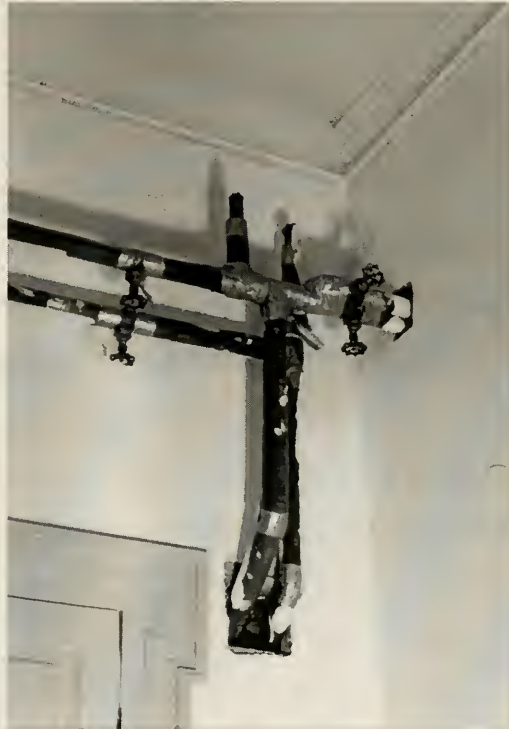
Figure 31 Destruction of Building Fabric Due to Inappropriate Mechanical System, 1998
Photograph by Author

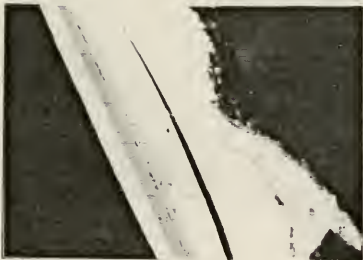
Sample 5: Paneled Door Jamb - Room Side

1. wood substrate
2. white (yellow) 5Y 9/2
3. white (purple blue) 5PB 9/1
4. white (purple blue) 5PB 9/1
5. white (purple blue) 5PB 9/1
6. white (purple blue) 5PB 9/1
7. yellow 2.5Y 8.5/4
8. white (yellow) 5Y 9/2
9. yellow 2.5Y 8.5/4
10. dark blue 7.5B 5/8
11. light blue 10B 6/8

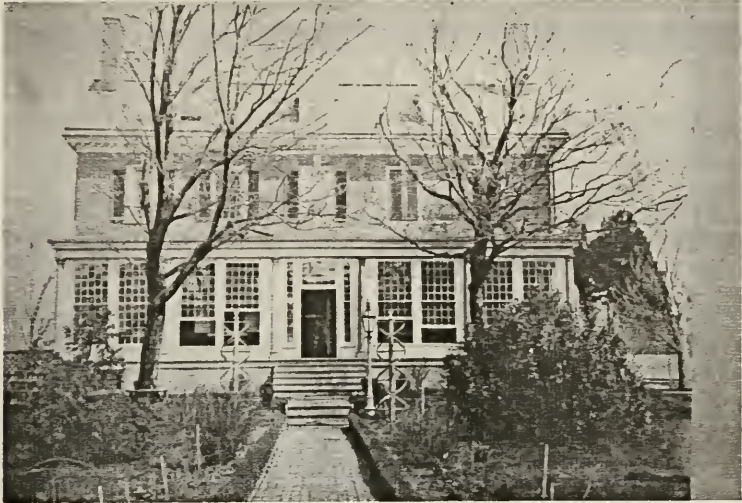
Figure 37 Mansion House, South Elevation
Photograph From Kirkbride Family Photo Album, 19th Century
Pennsylvania Hospital Archives, Philadelphia, PA

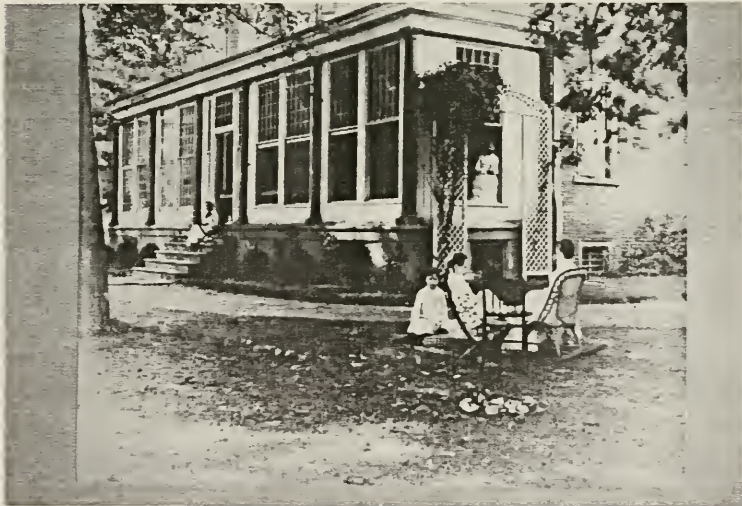
Figure 38 Mansion House, South Elevation
Photograph From Kirkbride Family Photo Album, 19th Century
Pennsylvania Hospital Archives, Philadelphia, PA

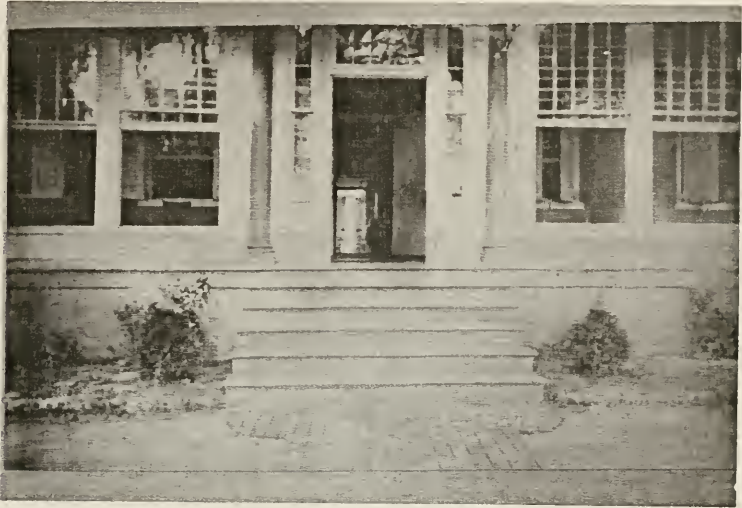
Figure 39 Mansion House, Detail of Porch (Portico) at South Elevation
Photograph From Kirkbride Family Photo Album, 19th Century
Pennsylvania Hospital Archives, Philadelphia, PA

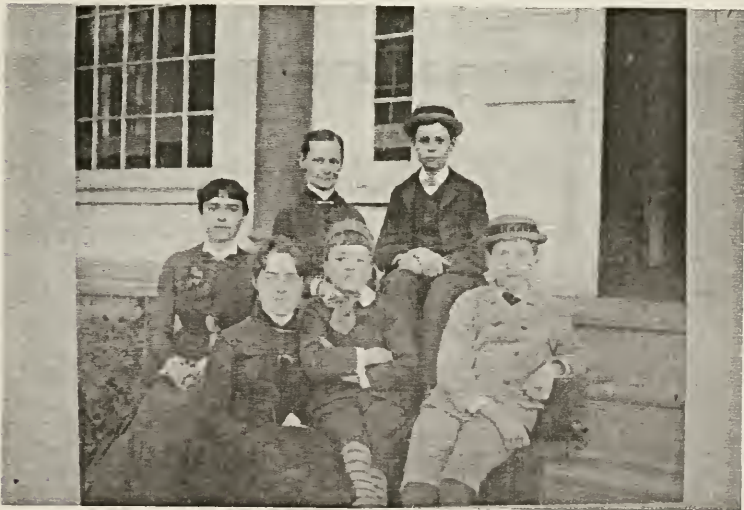
Figure 40 Mansion House, Detail of Porch (Portico) at South Elevation
Photograph From Kirkbride Family Photo Album, 19th Century
Pennsylvania Hospital Archives, Philadelphia, PA
